## WHITE HORSE STRATEGIC SOLUTIONS

### **Inspection Level 2 – Physical Inspection**

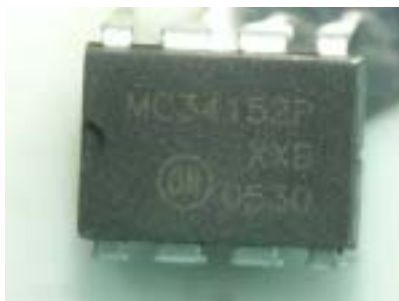
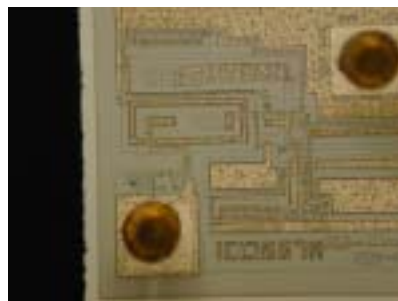
This component was marked as On Semi MC34152P; however Decapsulation revealed that the component was manufactured by Intersil. This component is counterfeit.

*Decapsulation* is a process by which we remove the plastic or ceramic insulation from the part to examine the internal die and wafer. This is a destructive test (parts cannot be used again after “decap”) but is the best way to determine whether components are counterfeit.

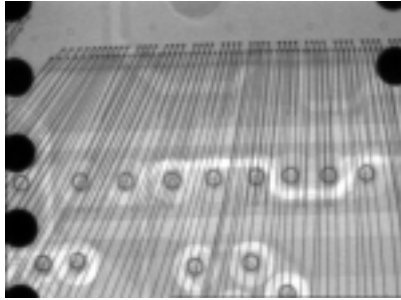
**Secure internal structure**

X-ray looks through the plastic or ceramic insulation on the part to the hardware inside (wafer, die, wires, substrate, solder joints, etc.). The first photograph shows a complex part with good wire bonding, no damage to wafer or die, and no crossed or broken wires.

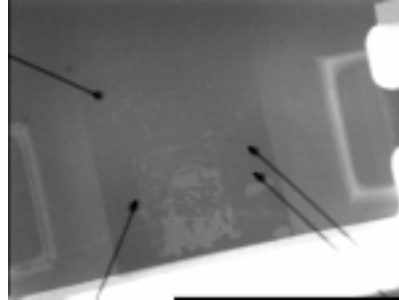
**Grey patches indicate moisture penetration**

The second photograph shows good wire bonding, wire integrity, and no cracks or breaks in the wafer; however, the grey patches between the three wires toward the bottom of the photograph are either water pockets that have penetrated the component insulation. When the part is placed on the circuit board and goes through a reflow oven, the water will heat and turn to steam and try to escape. This rapid expansion causes the insulation of the part to explode, often referred to as “popcorning”.

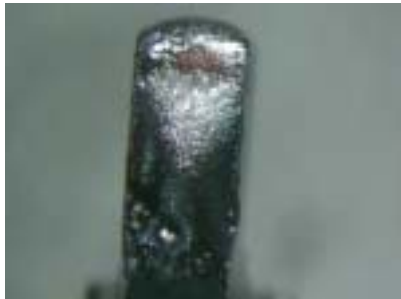
**Fail**

Using JEDEC standard JESD22-B102D for “dip and look” test, terminals are submerged in flux and then dipped in solder to evaluate solder coverage on the pads and solder wicking. The first component fails solderability at less than 95% and the second has full solder coverage, passing solderability test.

Parts that fail solderability will have difficulties “sticking” to the printed circuit board in application and will have poor electrical connection.

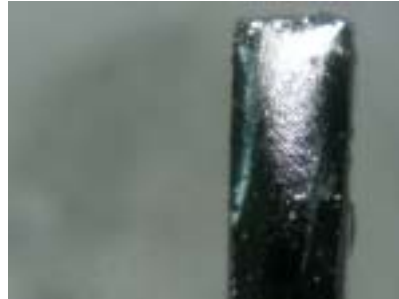
**Pass**
